Feb 8th, 2024

1234 Anywhere Street, Nashville, TN, 37221

# Home Inspection Report

Eric Cameron / Cameron Home Inspection

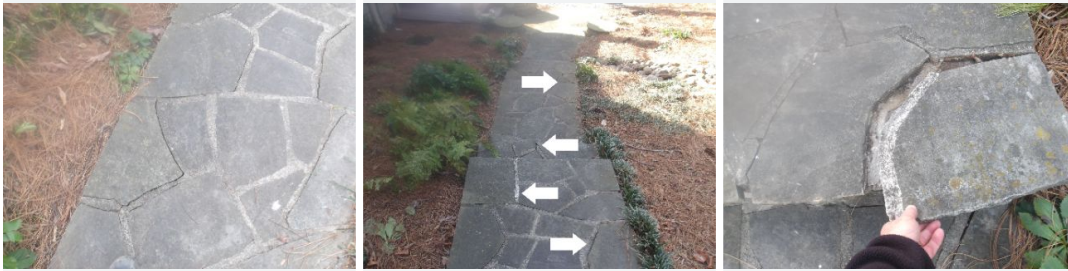
Cracks and loose stones noted at west side walkway.

**Marginal**

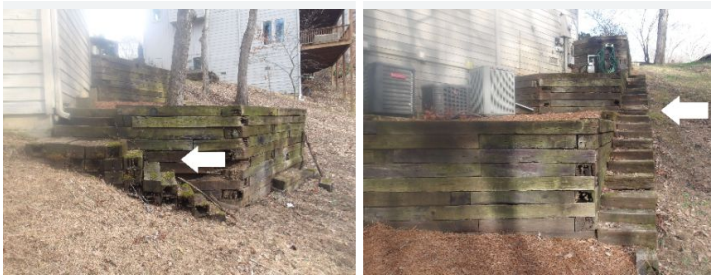
Extensive deterioration and wood rot at railroad tie steps on east side of the home.

**Marginal**

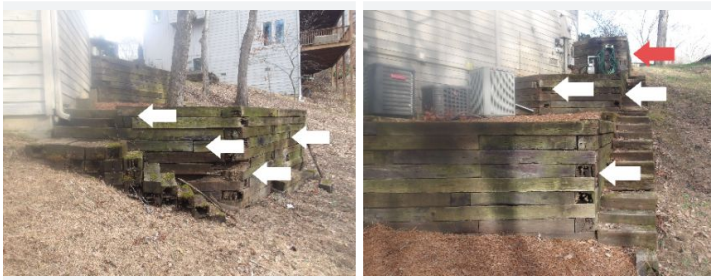
Railroad tie retaining walls are heavily deteriorated and beginning to fail.

Marginal

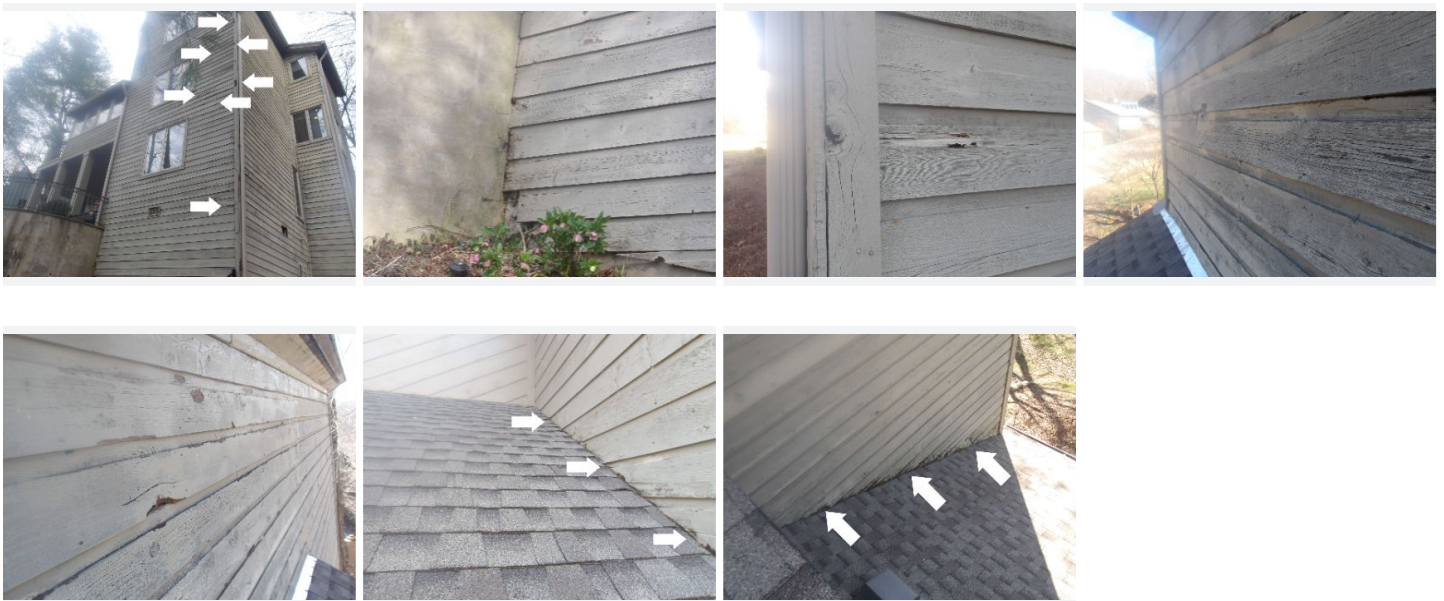
Many areas of wood rot and deterioration noted.  
Entire exterior of the home is in need of repairs, maintenance, paint and caulk.

Marginal

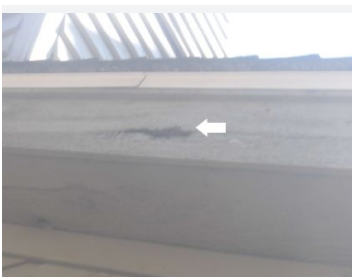
Wood rot noted. Suggest repairs/replacement and maintenance.

Marginal

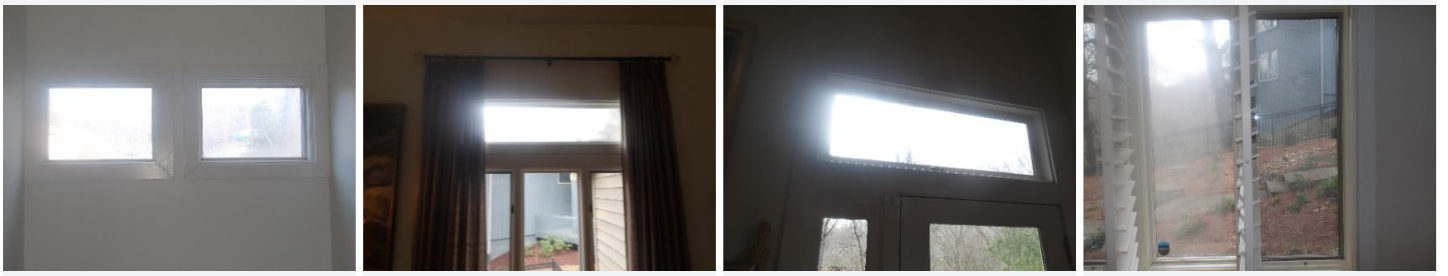
Some fogging and/or moisture noted between glass at several windows.

Marginal

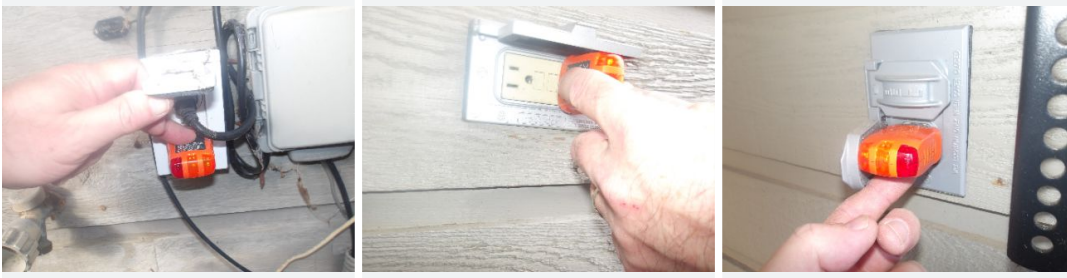
Missing and/or faulty GFCI protection at outlet under meter base, front porch and side wall at rear deck.

Marginal

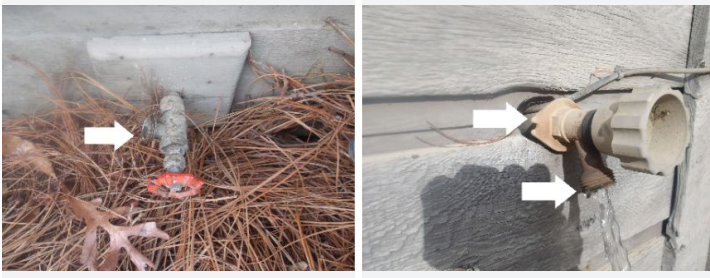
No back flow prevention noted on hose bibs.

Marginal

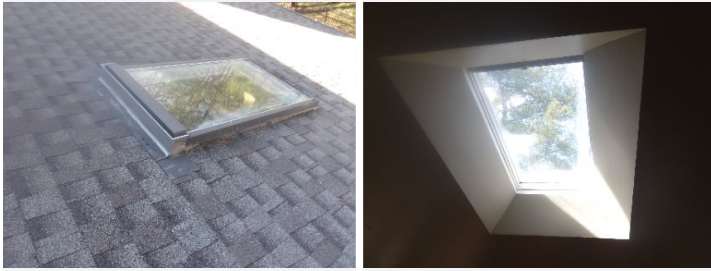
Fogged glass noted. No defect visible above on the roof.

Acceptable

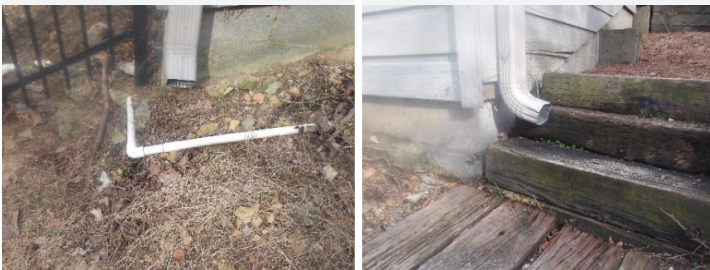
Ineffective and/or missing splash block(s) noted. Suggest that splash blocks be altered and/or replaced with buried leaders to better facilitate the run off and evacuation of water to a distance of at least 6' from the foundation.

Marginal

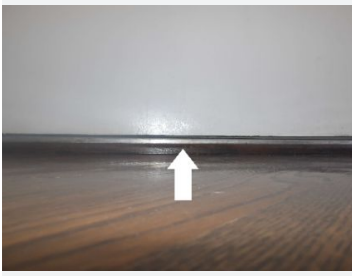
Gap under door sweep.

Marginal

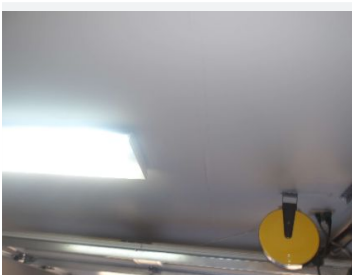
Cracks at drywall seams noted.

No defect visible in the attic areas above.

Cracks appear to be due to foot traffic and weight of stored items in attic above.

Acceptable

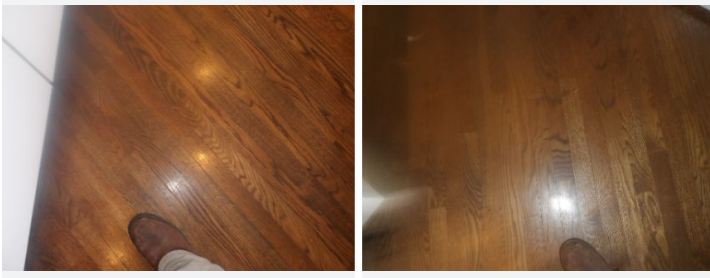
No defect visible below in the crawlspace.

Acceptable

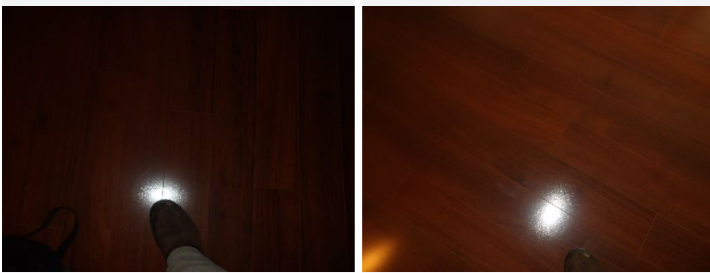
Bowing finish flooring in basement areas.

No defect visible.

Condition appears to likely be due to inadequate subfloor preparation and/or lack of expansion gap at perimeter of the rooms.

Acceptable

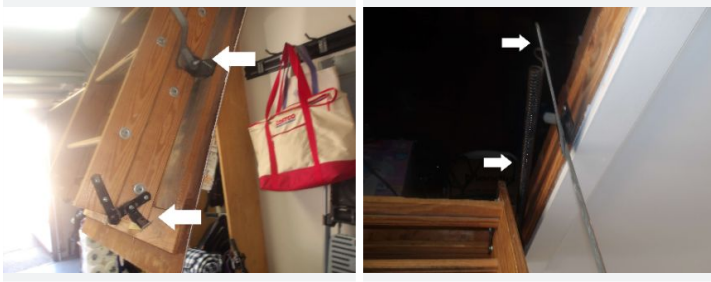
Pull down ladder for attic access in garage is heavily damaged and dangerous.

Marginal

Repairs/replacement needed.

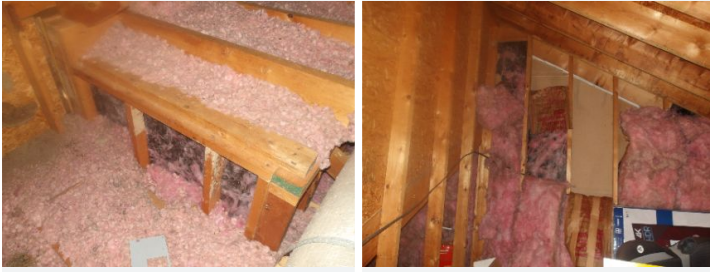
Fallen side wall insulation noted in both attic areas.

Marginal

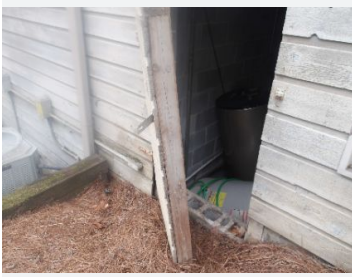
Door at access for front crawlspace is in need of repair.

Marginal

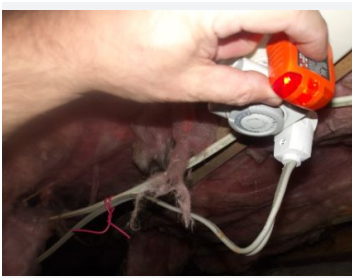
Non-GFCI circuit -recommend GFCI circuit be installed

Marginal

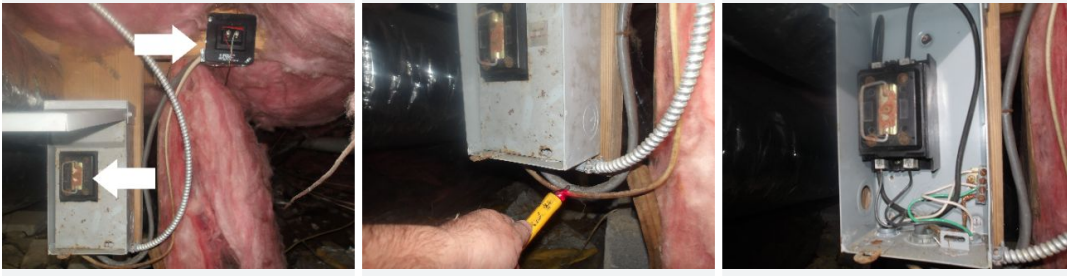
Electric disconnect panel noted in the rear crawlspace.

Circuit is live but is not labeled.

Marginal

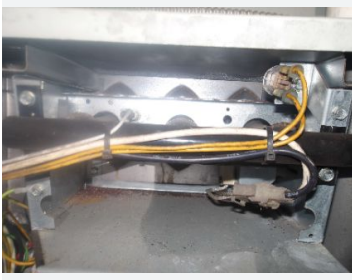
Excessive rust at interior of the heat exchanger.

Defective

Further evaluation by an HVAC service provider is recommended.

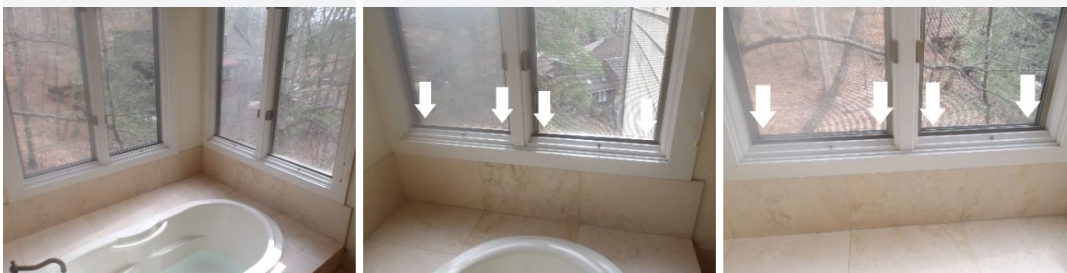
Window in shower/tub surround did not appear to be tempered/safety glass. Suggest consulting seller to verify.

Defective

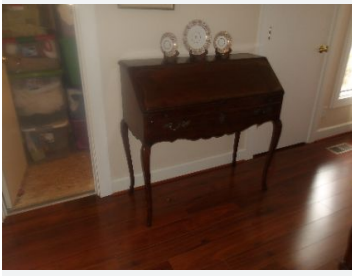
No outlet noted between closets.

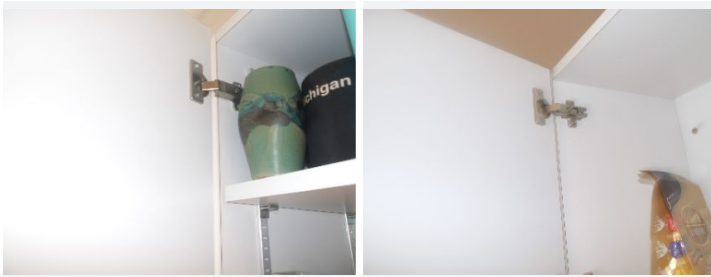
Two loose cabinet doors noted.

Marginal

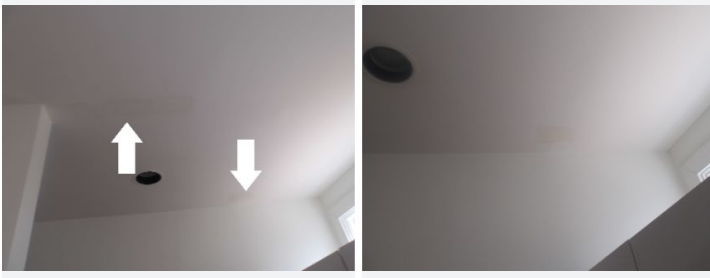
Water stains present under second floor bathroom area.

No moisture or defect noted at or above this area at the time of inspection.

Acceptable

Suggest that seller be consulted as to any history of defect and repairs in this area.

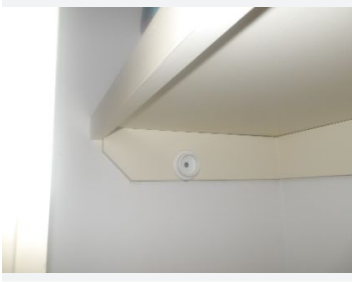
Missing clothes pole in one second floor hall closet.

Acceptable

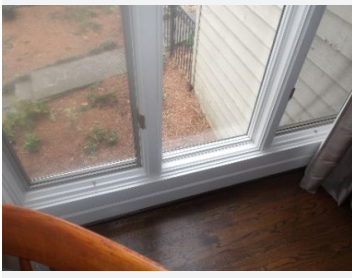
Window sills are close to the floor. This may be of concern if small children will be present.

Acceptable

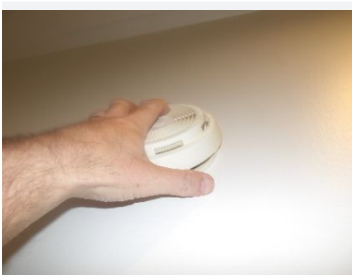
Second floor hall smoke detector did not respond.

Defective

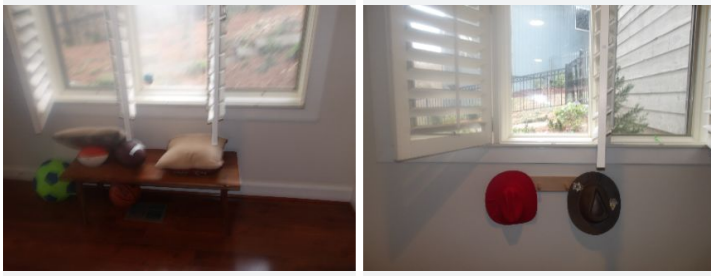
Windows were not opened due to missing crank handles.

Marginal

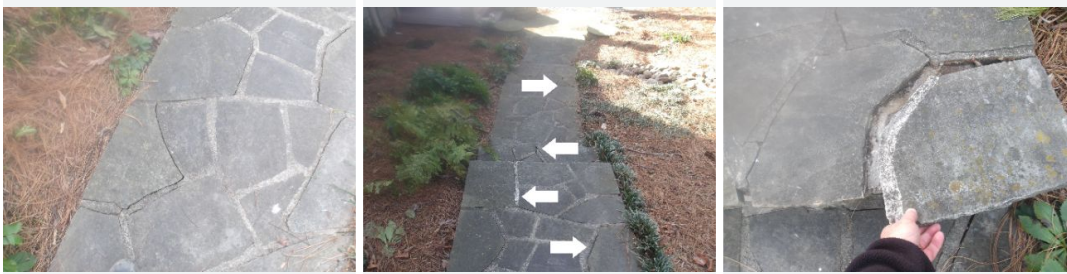
Cracks and loose stones noted at west side walkway.

Marginal

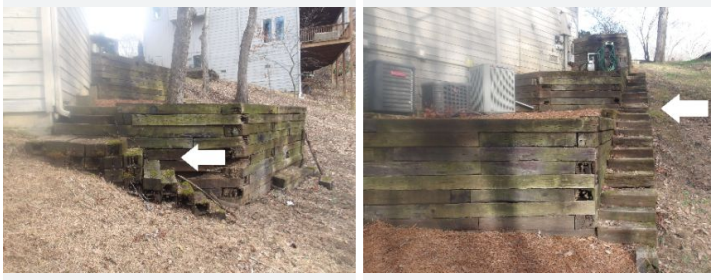
Extensive deterioration and wood rot at railroad tie steps on east side of the home.

Marginal

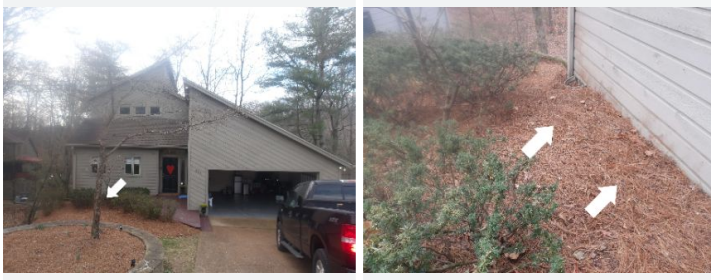
Recommend improvements be made to the grade, swale slope and depth to improve water control at front NE corner of the home.

Marginal

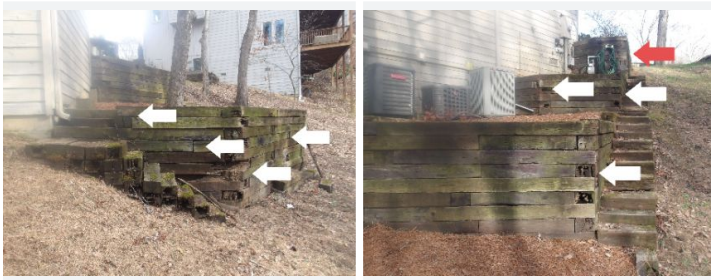
Railroad tie retaining walls are heavily deteriorated and beginning to fail.

Marginal

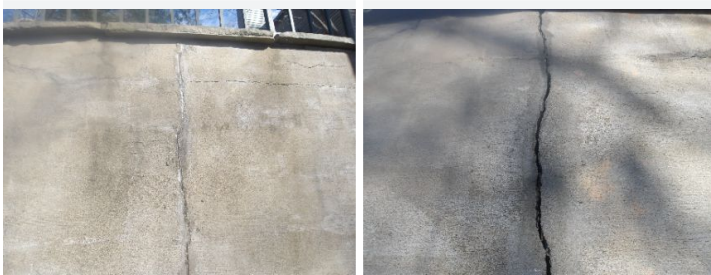
Cracks noted in the concrete retaining wall with some significant separation noted. No differential movement at the time of inspection.

Cracks need to be monitored for continued movement.

Marginal

Cracks needs to be repaired and sealed to hinder further deterioration.

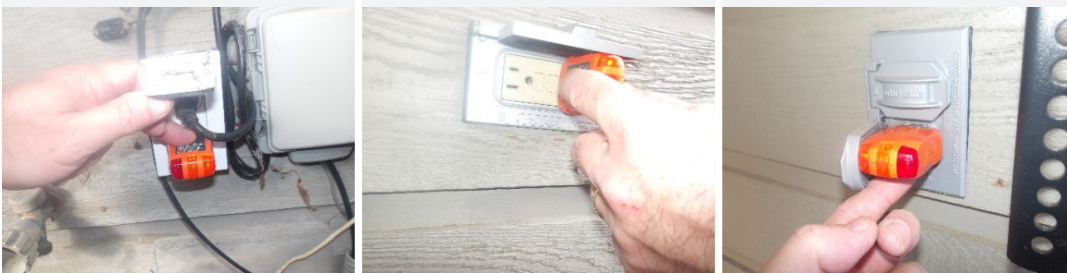
Missing and/or faulty GFCI protection at outlet under meter base, front porch and side wall at rear deck.

Marginal

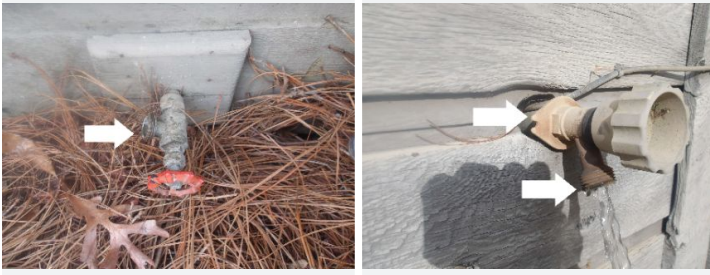
No back flow prevention noted on hose bibs.

Rear/east side hose bib is not secured to the wall.

Marginal

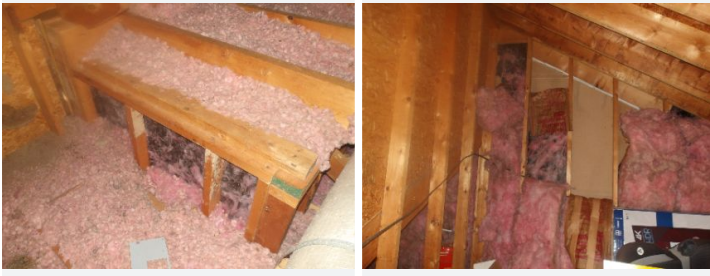
Fallen side wall insulation noted in both attic areas.

Marginal

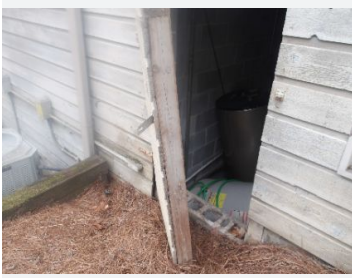
Door at access for front crawlspace is in need of repair.

Marginal

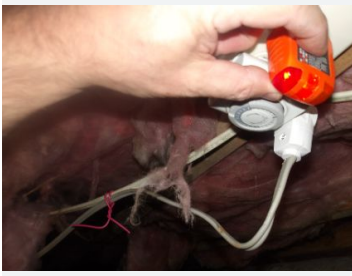
Non-GFCI circuit -recommend GFCI circuit be installed

Marginal

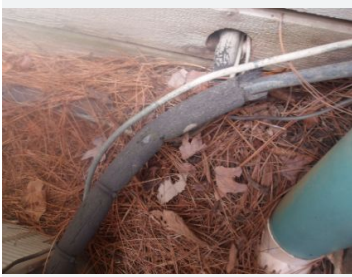
Damaged/deteriorated insulation noted. Suggest repairs/replacement.

Marginal

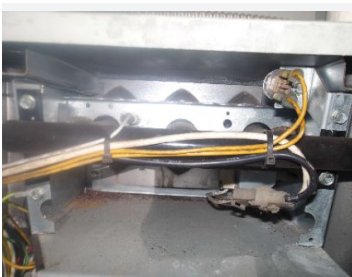
Excessive rust at interior of the heat exchanger.

Defective

Further evaluation by an HVAC service provider is recommended.

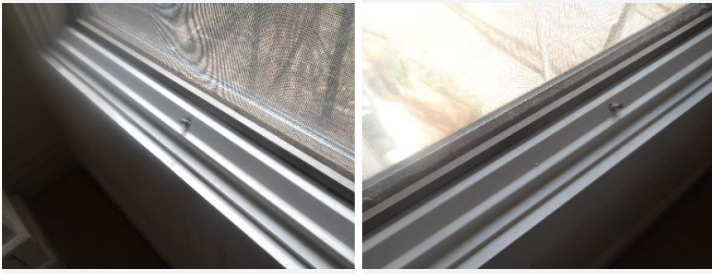
Windows could not be open due to missing crank handles.

Marginal

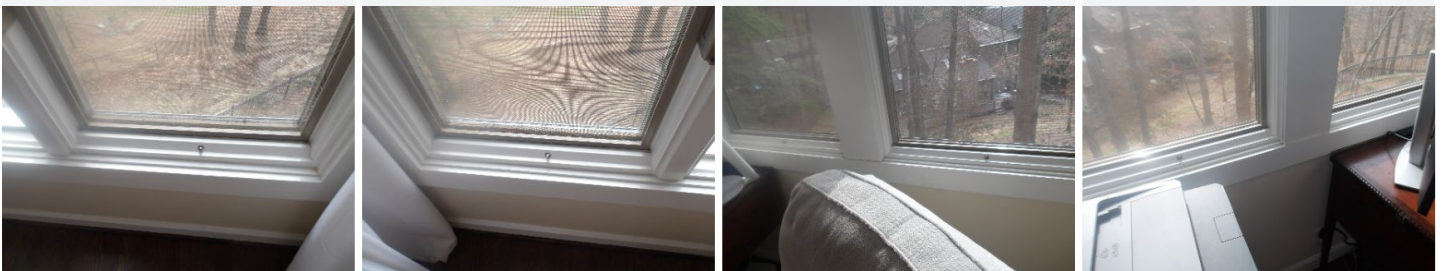
Windows could not be opened due to missing crank handles.

Marginal

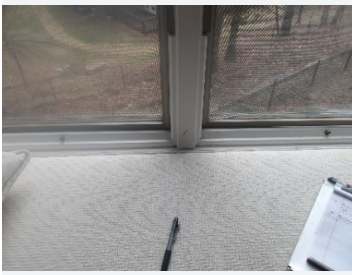
Windows were not opened due to missing crank handles.

Marginal

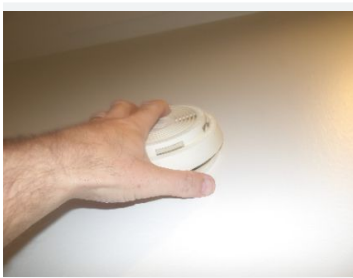
Second floor hall smoke detector did not respond.

Defective

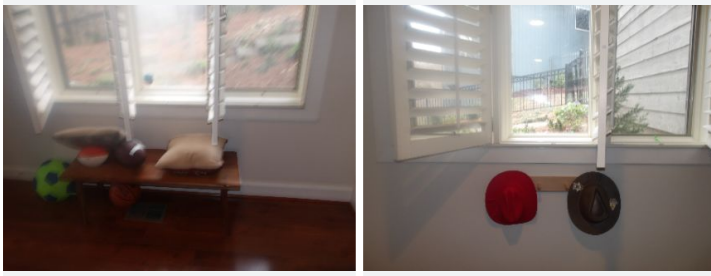
Windows were not opened due to missing crank handles.

Marginal

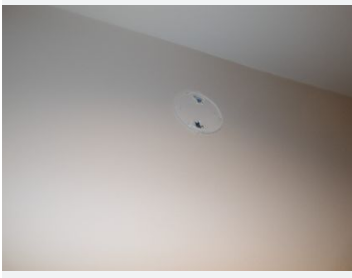
Hall smoke detector has been removed.

Defective
