Feb 8th, 2024

1234 Anywhere Street, Nashville, TN, 37221

# Home Inspection Report

Eric Cameron / Cameron Home Inspection

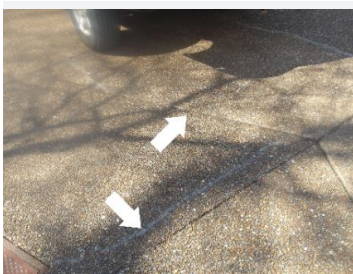
Cracks noted in the driveway with uneven settlement.  
 Suggest that cracks be repaired and sealed to hinder further deterioration.

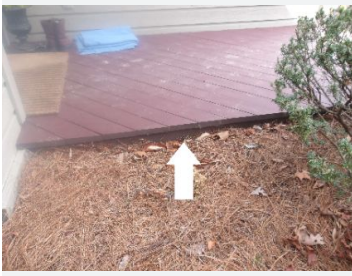
Extensive deterioration and wood rot at railroad tie steps on east side of the home.

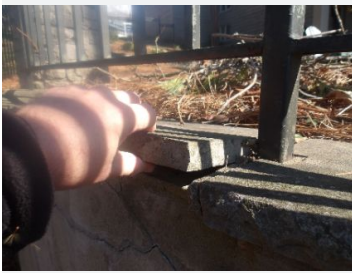
Loose cap stones noted at top of retaining wall around patio area.

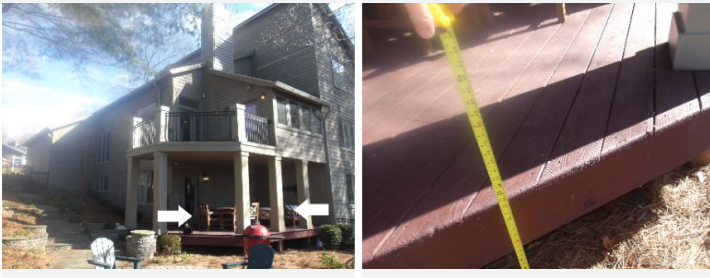
No railing noted for rear deck. This may be of concern if children will be present.

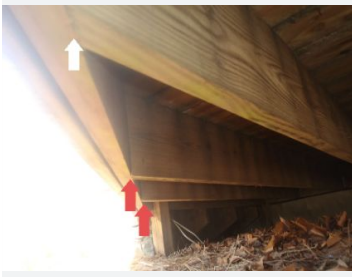
Several missing joist hangers at rear of deck.

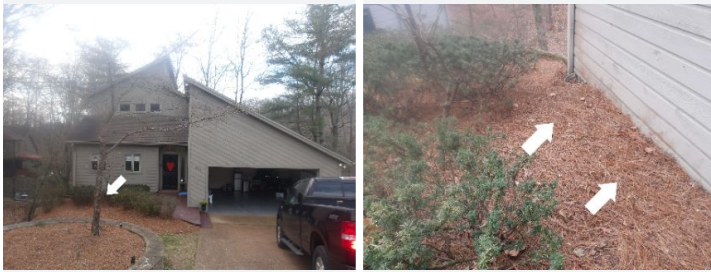
Recommend improvements be made to the grade, swale slope and depth to improve water control at front NE corner of the home.

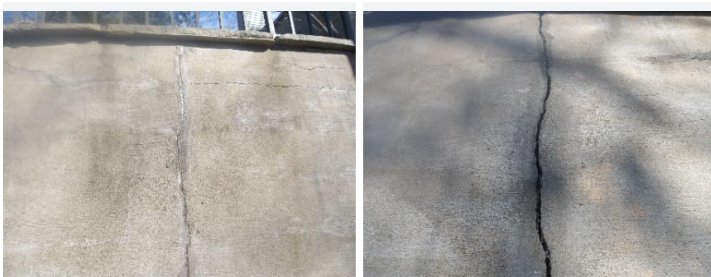
Cracks noted in the concrete retaining wall with some significant separation noted. No differential movement at the time of inspection.

Cracks needs to be repaired and sealed to hinder further deterioration.

Cracks need to be monitored for continued movement.

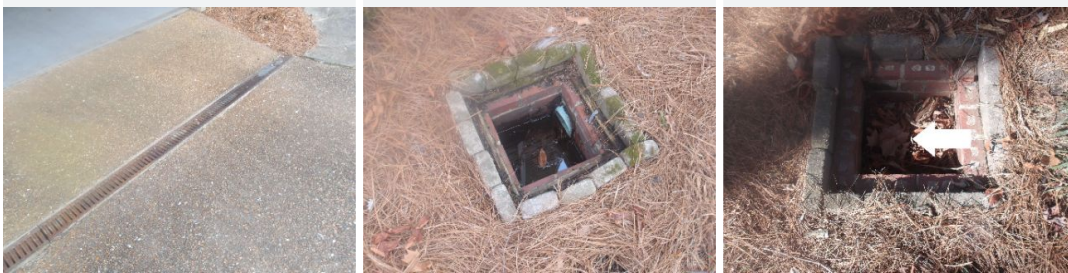
No outlets located for the driveway surface drain or side/rear yard surface drains. Outlet points needs to be located to verify that they are free flowing and facilitates the drainage and run off of water away from the foundation.

No grates over side/rear yard surface drains to filter debris. Excessive debris noted in mouth of one drain.

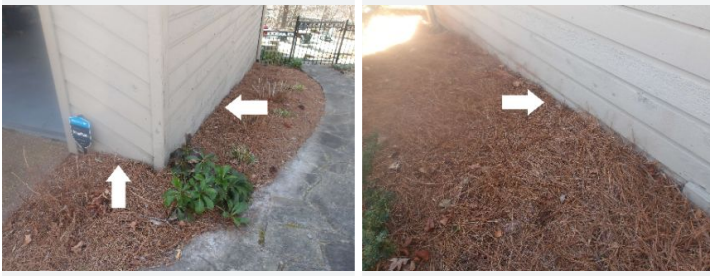
Many areas of wood rot and deterioration noted.  
Entire exterior of the home is in need of repairs, maintenance, paint and caulk.

All grade and ground cover need to be pulled away from contact with the wood siding. Siding clearance should be between 6"-8" from grade.

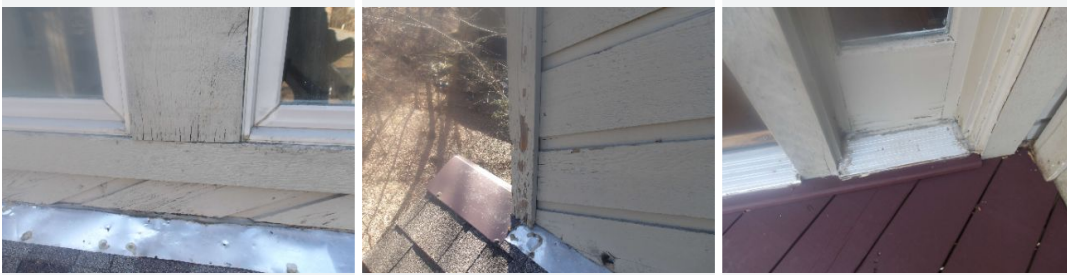
Paint, sealant and maintenance needed at all trim on the exterior of the home.

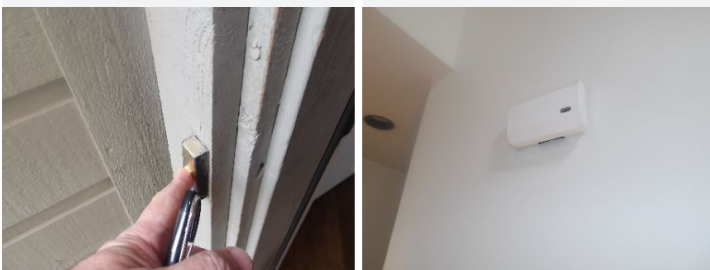
Traditional hard wired door bell did not respond.

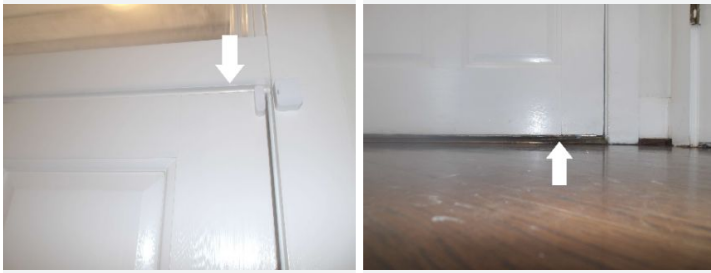
Gap under door sweep.

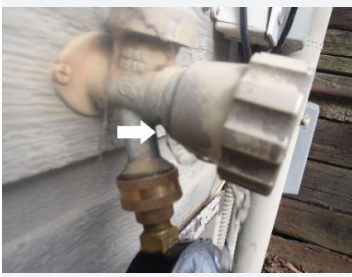
No back flow prevention noted on hose bibs.

Leak at valve stem for hose bib under electric meter when valve is open.

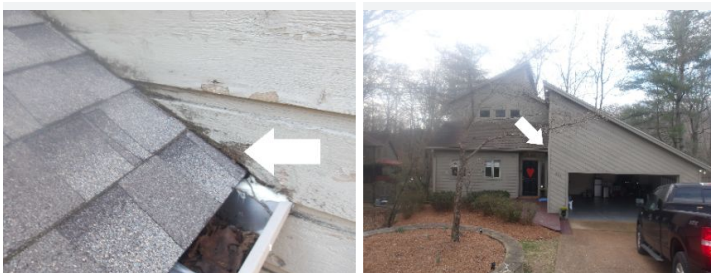
Missing kick out flashing.

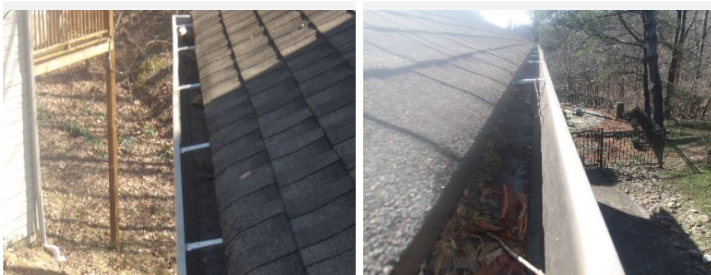
Gutters are clogged and need to be cleared.

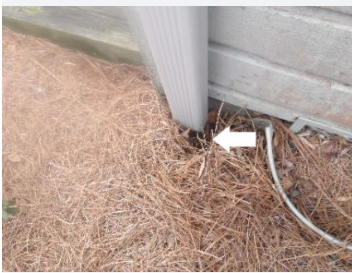
Entry point for buried leader at front corner was not visible and is disconnected from the downspout.

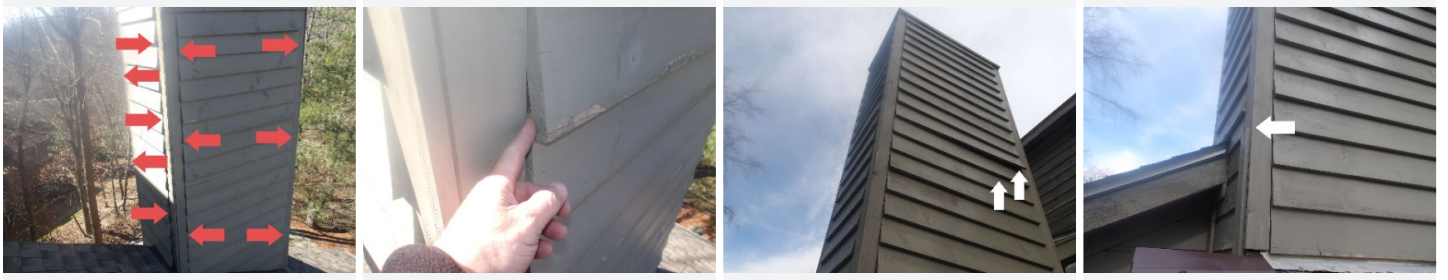
Siding on chimney has been poorly installed and is in need of repairs. Loose boards, No caulk at joints and seams noted.

Further evaluation and repairs by a qualified contractor is needed.

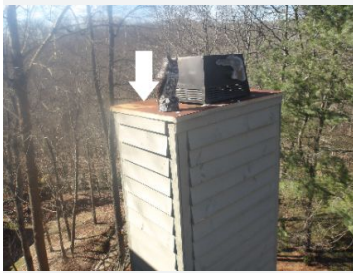
Corrosion noted at the metal chimney cap. Suggest maintenance with appropriate paint to hinder further deterioration.

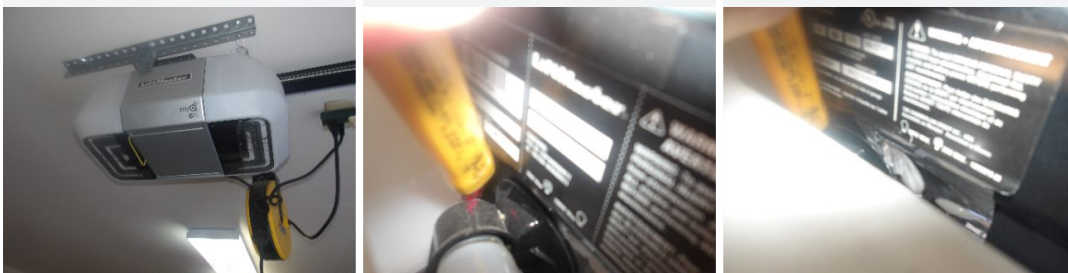
Light(s) in door opener did not respond. No visible sign of defect. Likely due to old bulb(s) Suggest that bulbs be changed and tested.

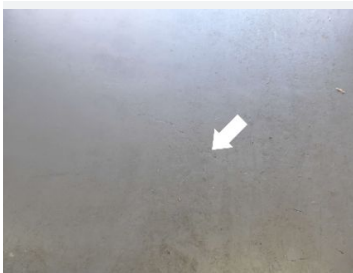
Cracks noted in the garage floor. No uneven settlement or structural deficiency. Suggest that cracks be repaired and sealed.

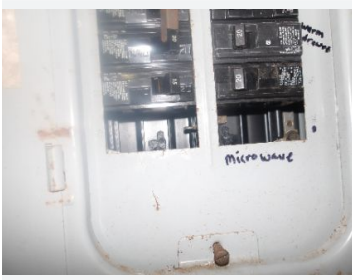
No twist out covers for two missing breakers.

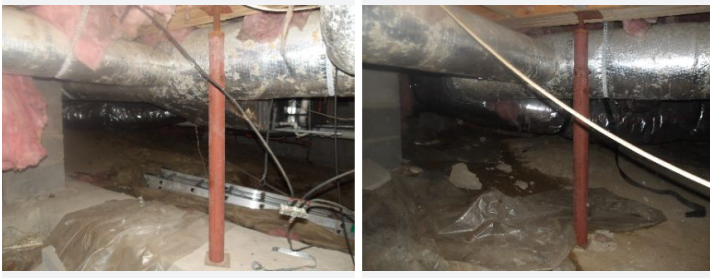
Supplemental posts noted in crawlspace.

No defect visible. Appears that posts were likely installed to remedy a squeaking floor.

Suggest that seller be consulted as to why these posts have been installed.

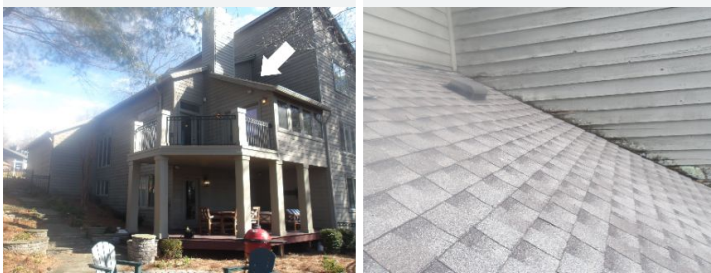
Area over office in master suite was not readily visible/accessible.

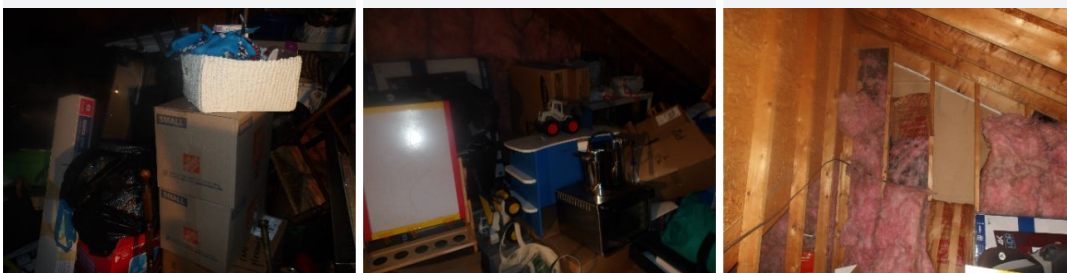
Most of the attic area over the garage was not readily visible/accessible due to stored items.

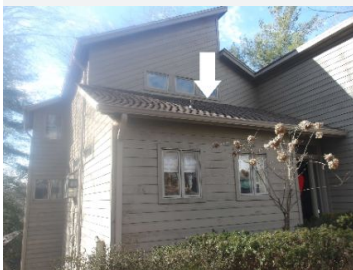
No roof vents for attic area under front shed roof.

Suggest that roof vents be installed when a new roof surface is needed.

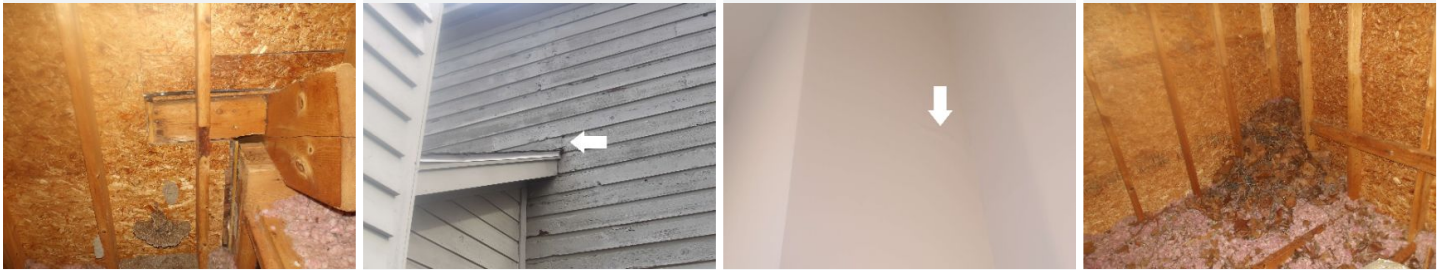
Area of discoloration and repairs noted in attic over second floor. No moisture or defect noted at time of inspection. Repairs noted/visible on the roof/wall surface. Suggest that repairs be maintained and periodically monitored for moisture and/or continued discoloration.

Some moisture damage noted to paint surface at master bedroom wall below this area.

Appears that the repairs and moisture intrusion were due to squirrel intrusion nesting in the attic. Suggest that all nesting material be removed from the attic.

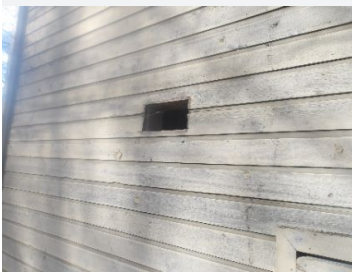
Missing vent screen.

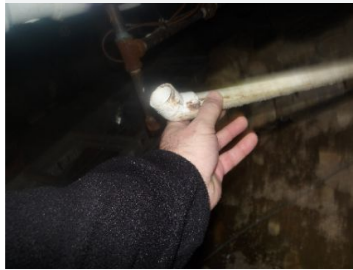
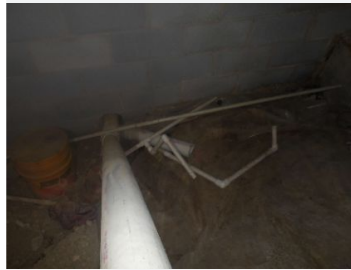
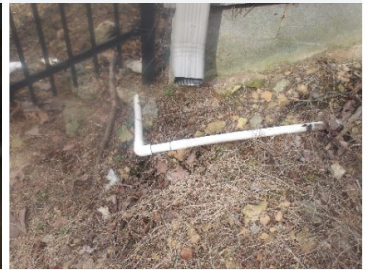
No condensate overflow pan and float switch.

Auxiliary condensate drain line has been disconnected and outlet has become buried.

Further evaluation by an HVAC service provider recommended.

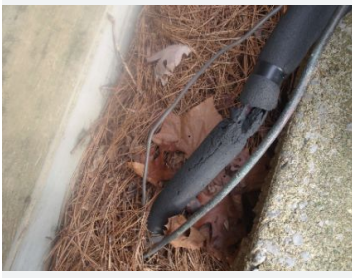
Damaged/deteriorated insulation noted. Suggest repairs/replacement.

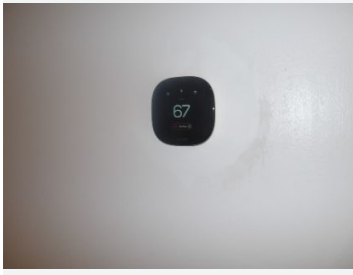
Suggest seller be consulted as to the operation and full capabilities of the digital thermostat.

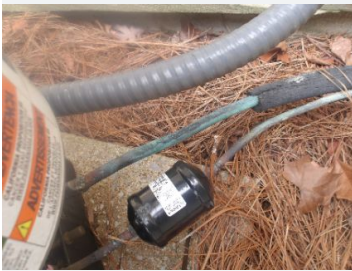
Damaged/deteriorated insulation noted. Suggest repairs/replacement.

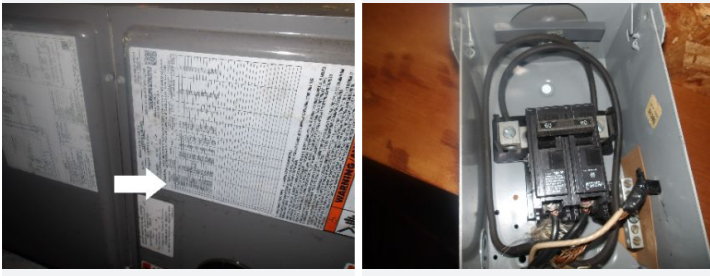
Properly sized over current protection was not verified for the heater kit due to installer failing to designate the heat kit on the data plate.

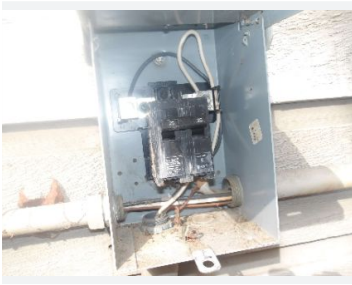
Oversized breaker. Data plate specifies a maximum over current protection of 20amps.

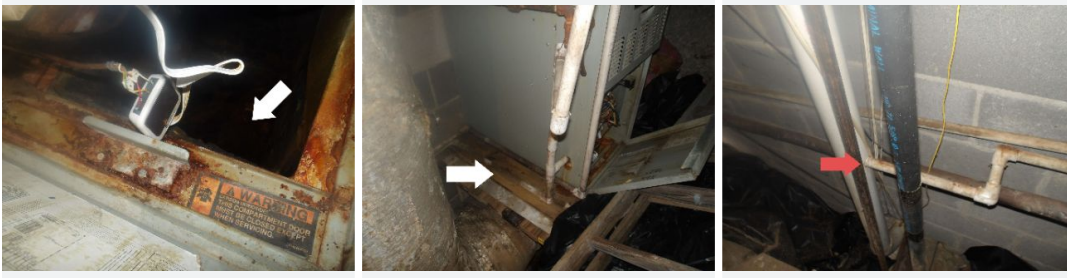
No condensate overflow pan and float switch noted under this unit.

Moisture note in return duct under this unit.

Further evaluation by an HVAC service provider recommended.

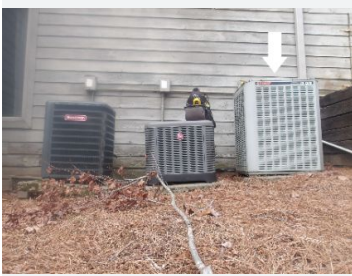
Unit is out of level. Suggest that pad be leveled and stabilized to hinder possible stress on the refrigerant and/or gas lines.

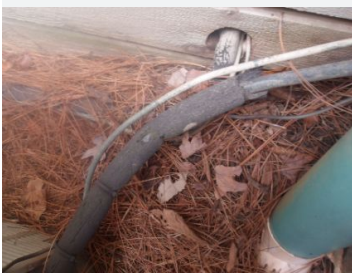
Damaged/deteriorated insulation noted. Suggest repairs/replacement.

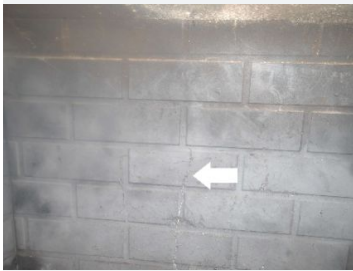
Crack noted at rear wall of the fire box. Suggest that this be repaired prior to use.

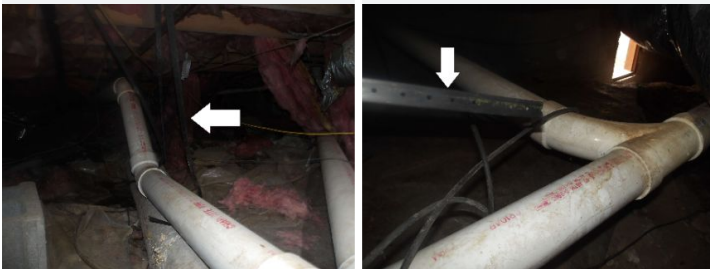
Two broken support straps for drain line in rear crawlspace.

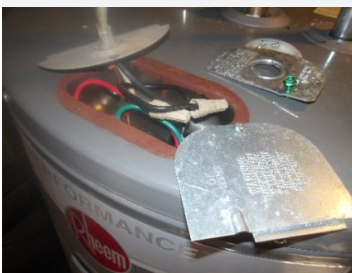
Junction box is open and should be covered.

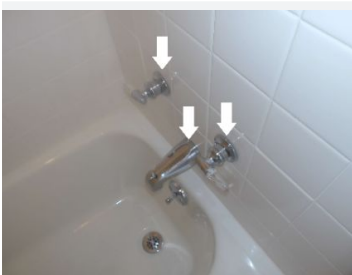
Sealant suggested around base of the tub/shower fixtures.

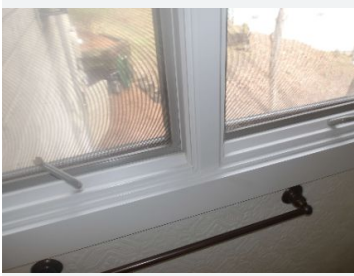
Water closet windows did not open.

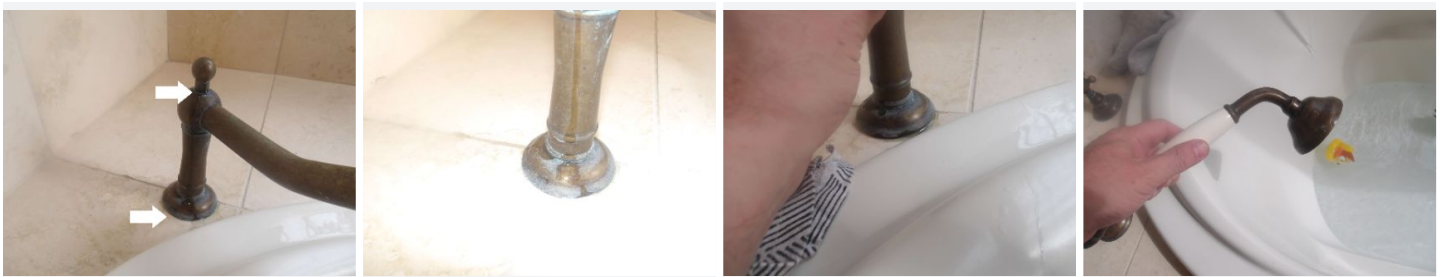
Tub faucet is loose at base and leaks when valve is open.

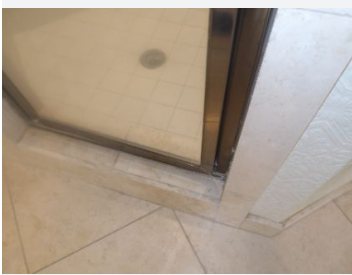
Shower door sticks.

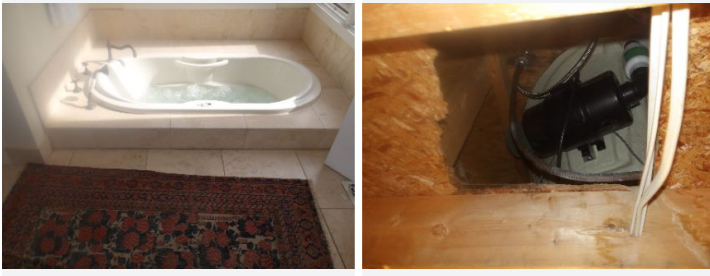
Spa motor is only accessible from mechanical closet in basement below.

No GFCI protection located for spa motor circuit.

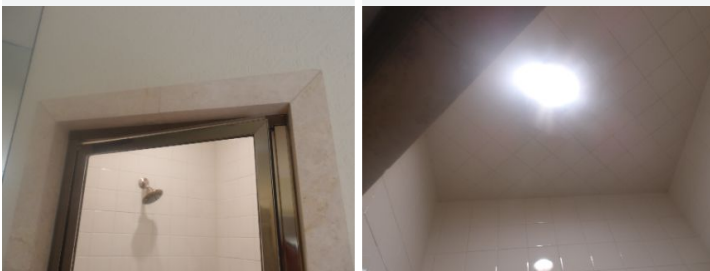
No venting noted for the shower stall.

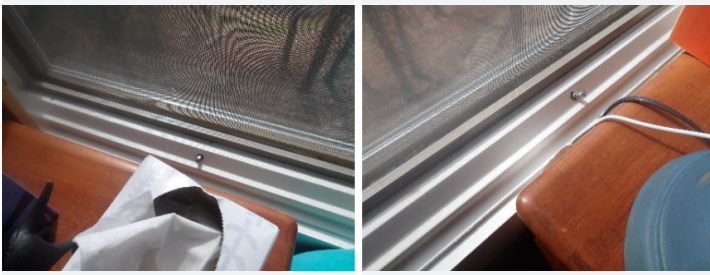
Windows could not be opened due to missing crank handles.

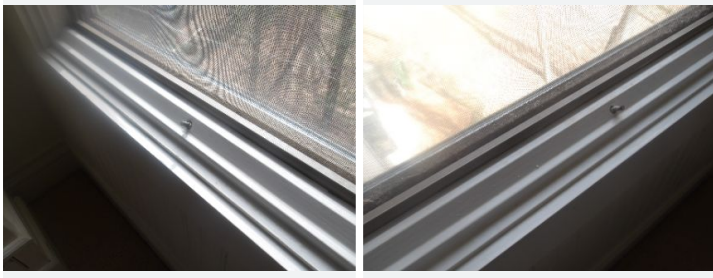
Windows could not be open due to missing crank handles.

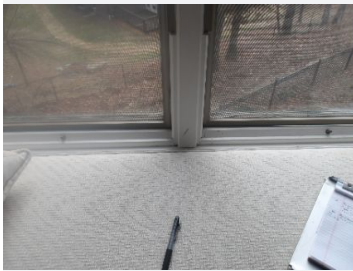
Windows were not opened due to missing crank handles.

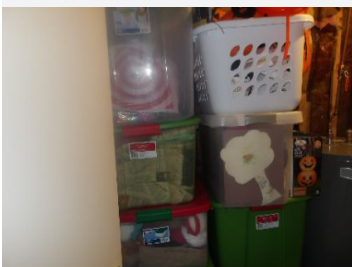
Most of the interior of the mechanical closet was not visible due to stored items.

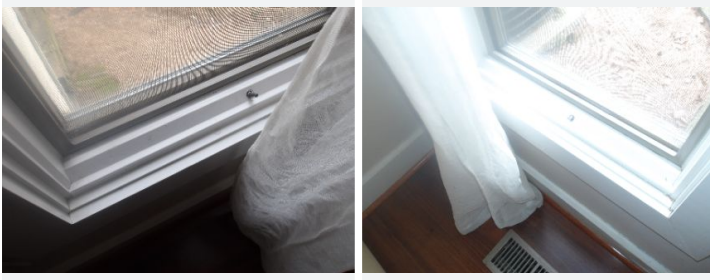
Windows were not opened due to missing crank handles.

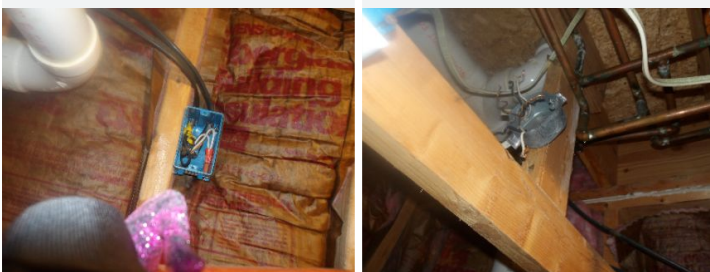
Open junction boxes in mechanical closet.  
No current at ceiling outlet in mechanical closet.

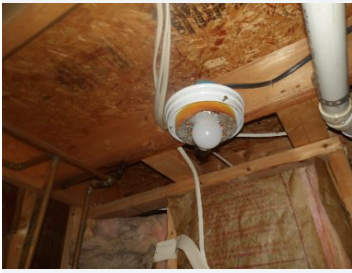
Missing bulb cover in closet.

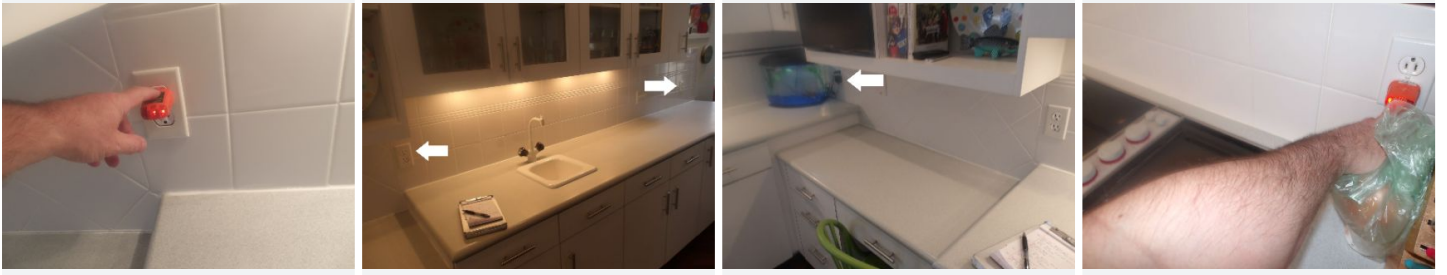
No GFCI protection noted at rear wall counter outlets or outlet at cook top counter.

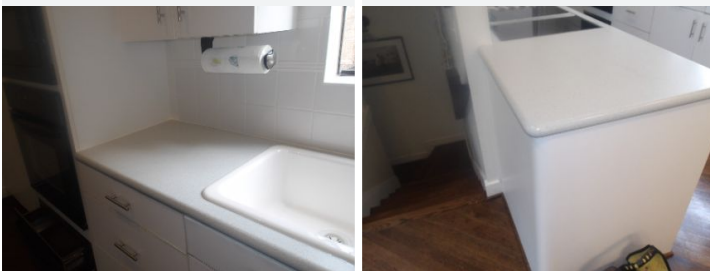
No outlets left of sink and left of cook top.

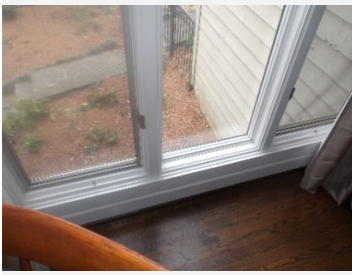
Windows were not opened due to missing crank handles.

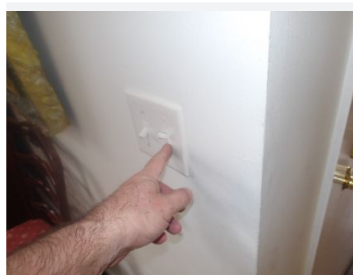
No outlet noted in second floor hall.

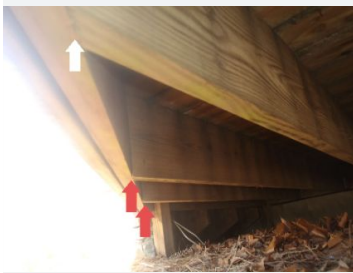
Several missing joist hangers at rear of deck.

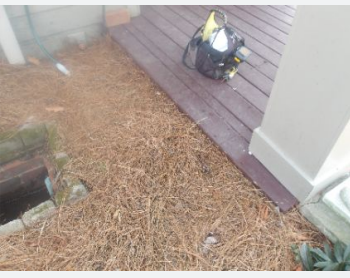
Deck is in contact with the ground. Deck materials need to have clearance above grade.

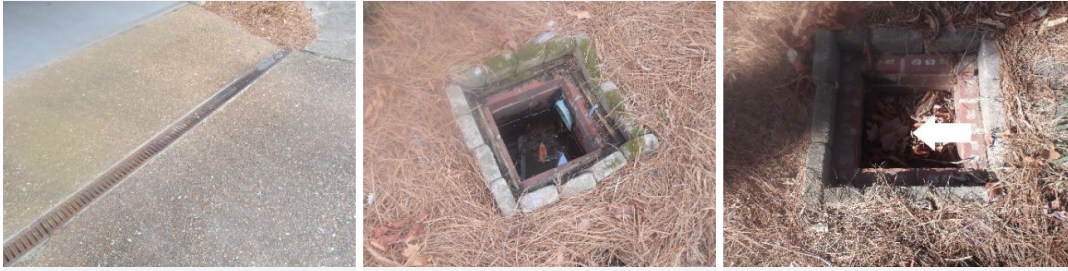
No outlets located for the driveway surface drain or side/rear yard surface drains. Outlet points needs to be located to verify that they are free flowing and facilitates the drainage and run off of water away from the foundation.

No grates over side/rear yard surface drains to filter debris. Excessive debris noted in mouth of one drain.

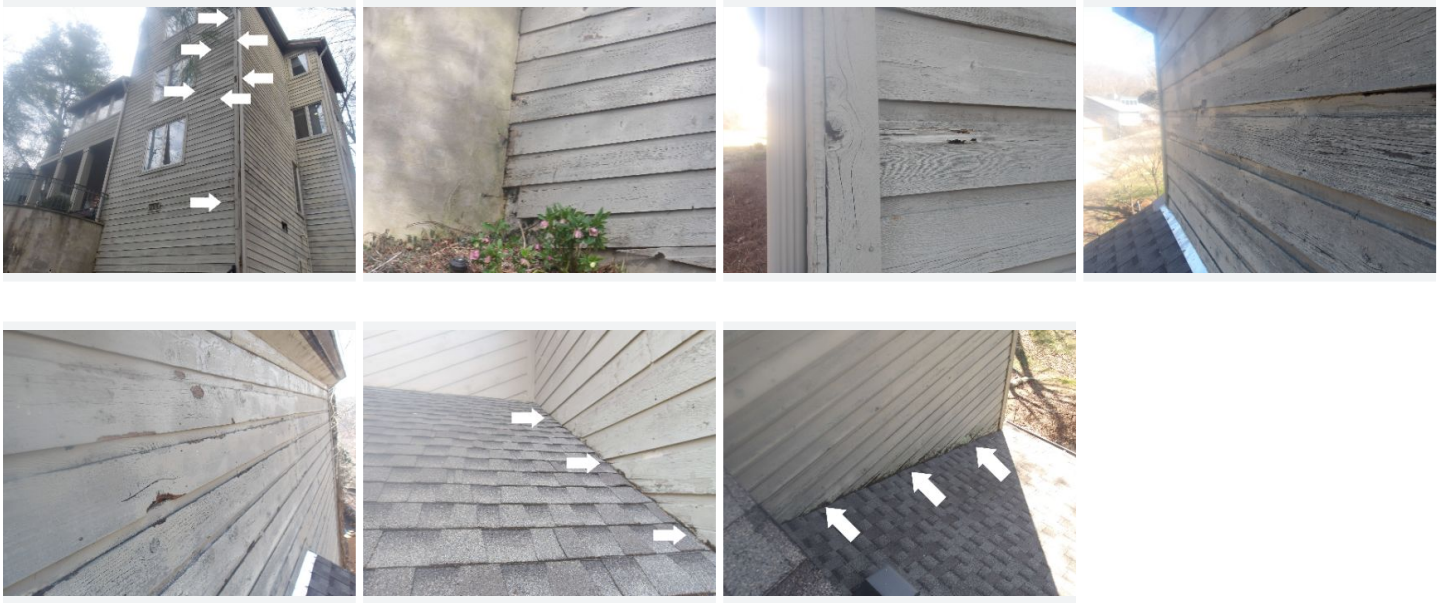
Many areas of wood rot and deterioration noted.

Entire exterior of the home is in need of repairs, maintenance, paint and caulk.

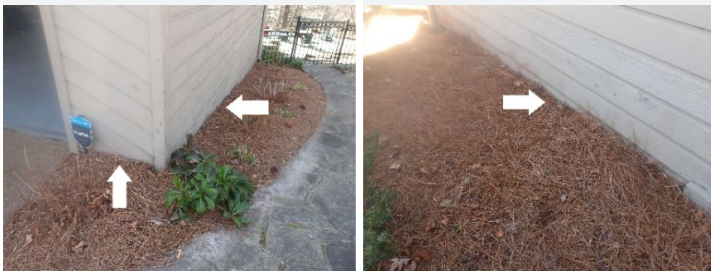
All grade and ground cover need to be pulled away from contact with the wood siding. Siding clearance should be between 6"-8" from grade.

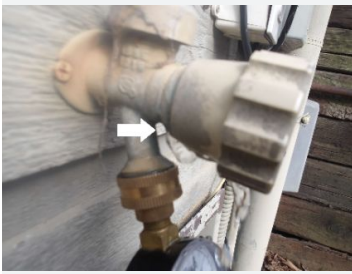
Leak at valve stem for hose bib under electric meter when valve is open.

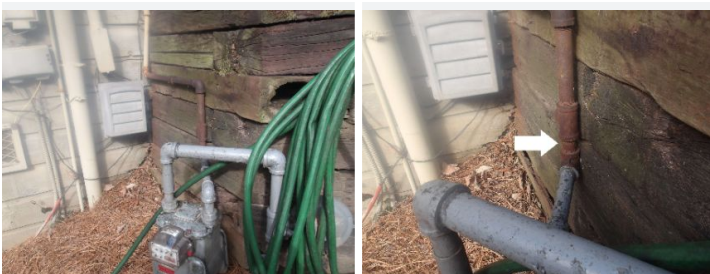
Retaining wall is in contact with gas line at meter base. This needs to be addressed before the wall stresses the gas line connections.

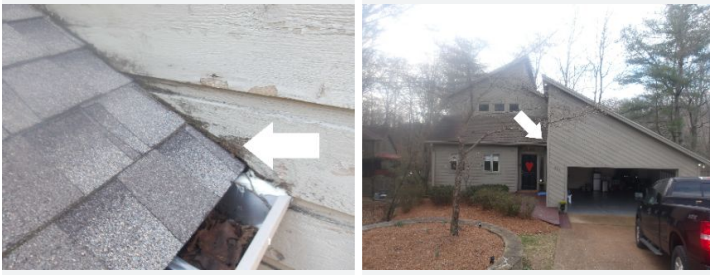
Missing kick out flashing.

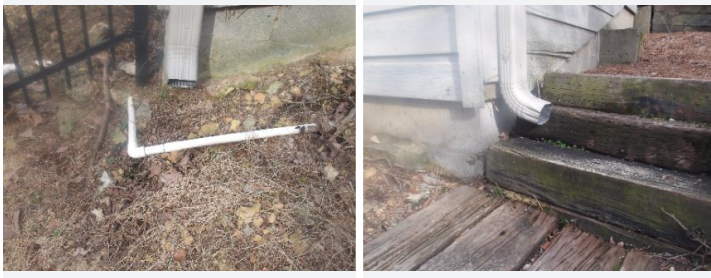
Ineffective and/or missing splash block(s) noted. Suggest that splash blocks be altered and/or replaced with buried leaders to better facilitate the run off and evacuation of water to a distance of at least 6' from the foundation.

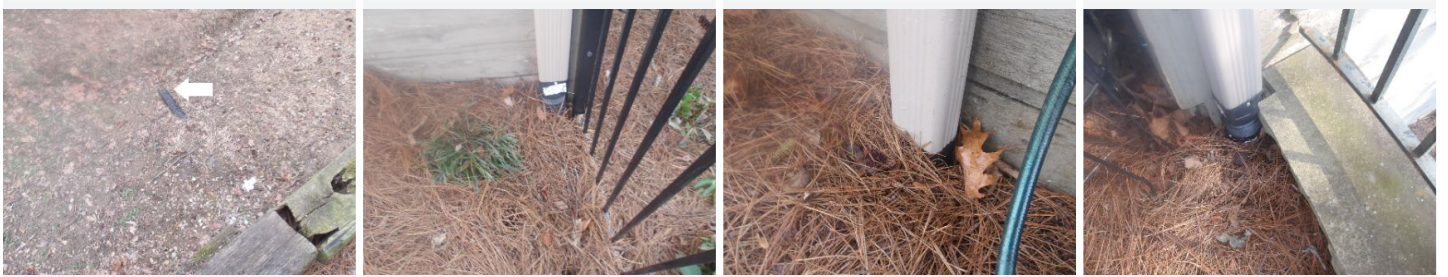
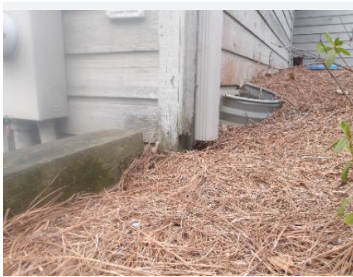
Only one outlet point was located for the buried leaders.

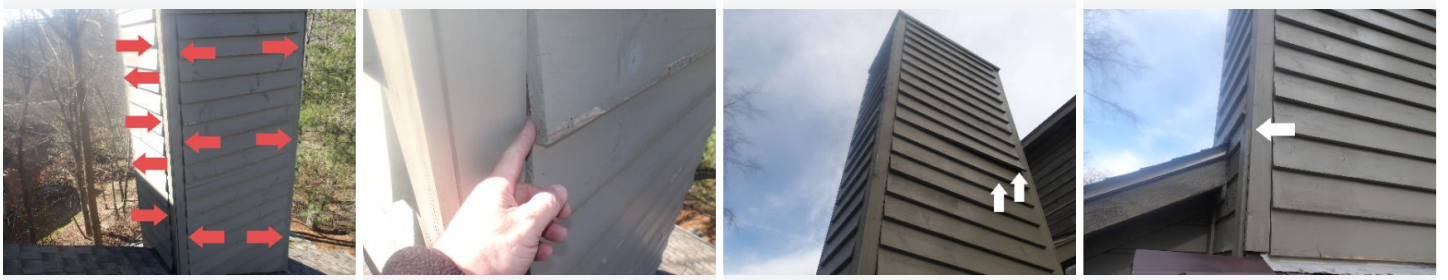
Siding on chimney has been poorly installed and is in need of repairs. Loose boards, No caulk at joints and seams noted.

Further evaluation and repairs by a qualified contractor is needed.

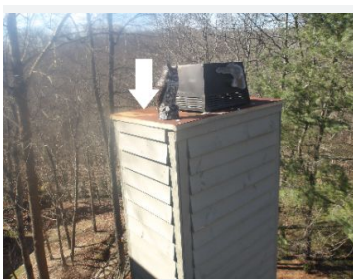
Corrosion noted at the metal chimney cap. Suggest maintenance with appropriate paint to hinder further deterioration.

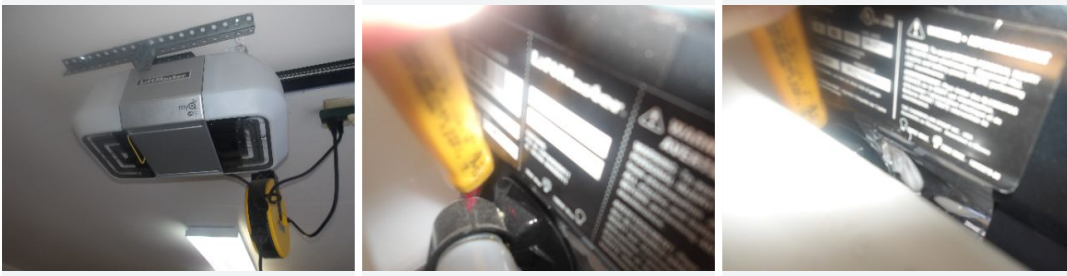
Light(s) in door opener did not respond. No visible sign of defect. Likely due to old bulb(s) Suggest that bulbs be changed and tested.

Current was present at bulb sockets.

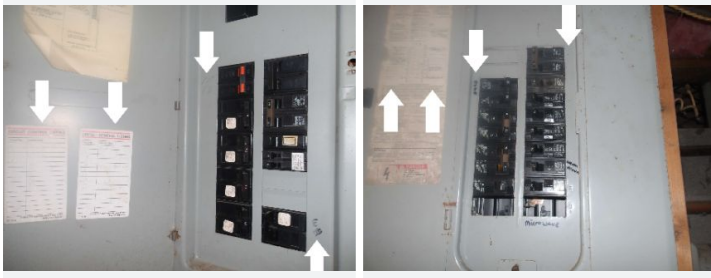
Circuits are not fully/clearly labeled in the main panel and the distribution panel.

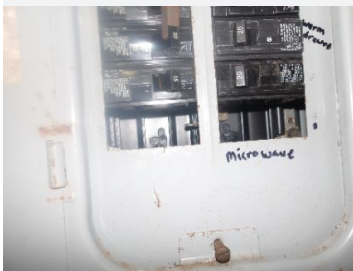
No twist out covers for two missing breakers.

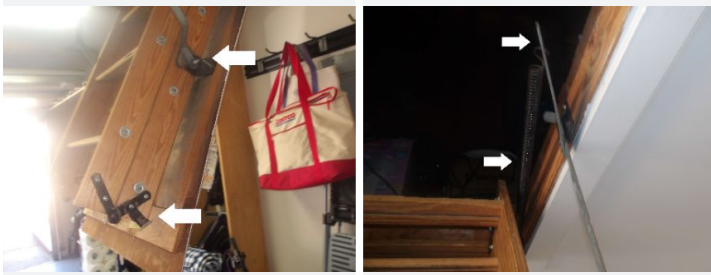
Pull down ladder for attic access in garage is heavily damaged and dangerous.

Repairs/replacement needed.

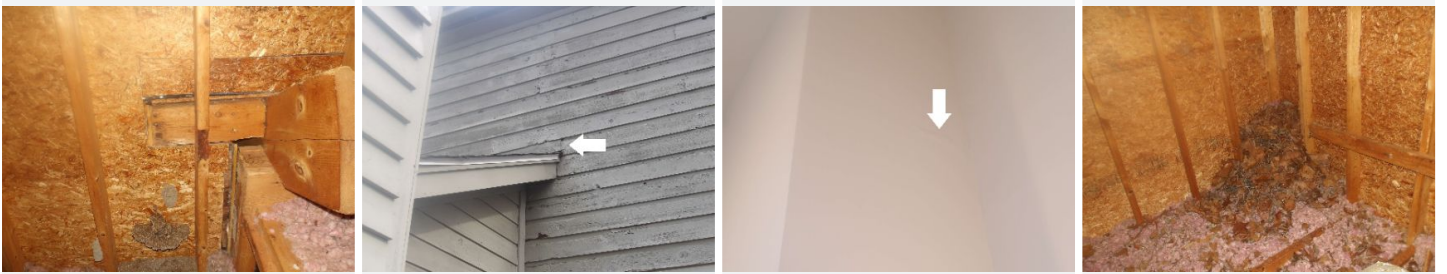
Area of discoloration and repairs noted in attic over second floor. No moisture or defect noted at time of inspection. Repairs noted/visible on the roof/wall surface. Suggest that repairs be maintained and periodically monitored for moisture and/or continued discoloration.

Some moisture damage noted to paint surface at master bedroom wall below this area.

Appears that the repairs and moisture intrusion were due to squirrel intrusion nesting in the attic. Suggest that all nesting material be removed from the attic.

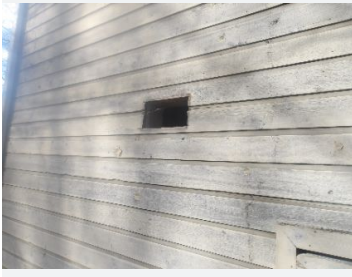
Missing vent screen.

Suggest that additional vents be installed to allow for cross ventilation.

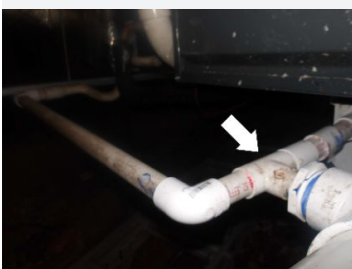
No condensate overflow pan and float switch.

Auxiliary condensate drain line has been disconnected and outlet has become buried.

Further evaluation by an HVAC service provider recommended.

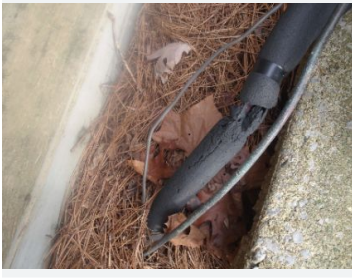
Damaged/deteriorated insulation noted. Suggest repairs/replacement.

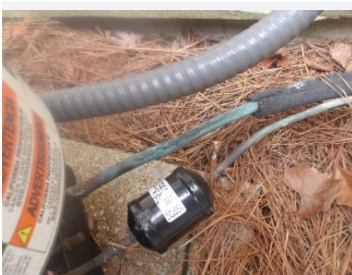
Damaged/deteriorated insulation noted. Suggest repairs/replacement.

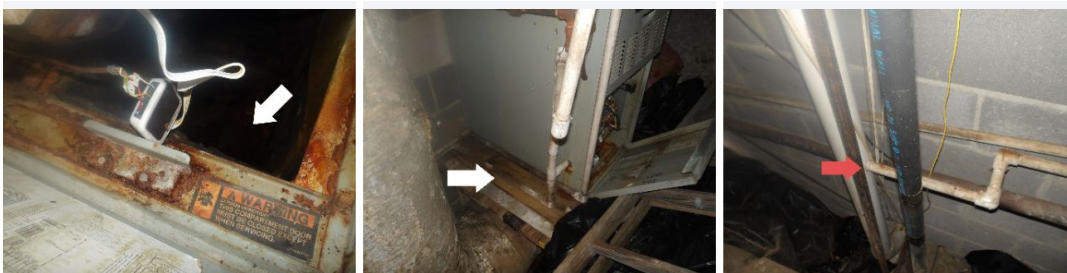
No condensate overflow pan and float switch noted under this unit.

Moisture note in return duct under this unit.

Further evaluation by an HVAC service provider recommended.

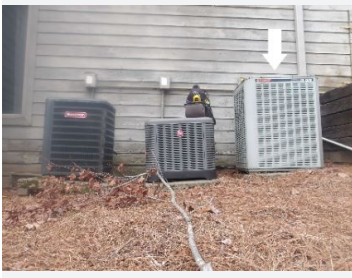
Unit is out of level. Suggest that pad be leveled and stabilized to hinder possible stress on the refrigerant and/or gas lines.

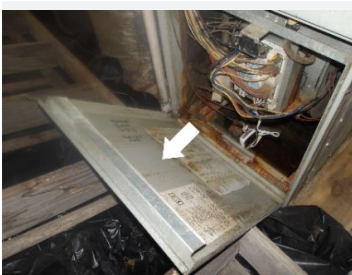
Damaged/deteriorated insulation noted. Suggest repairs/replacement.

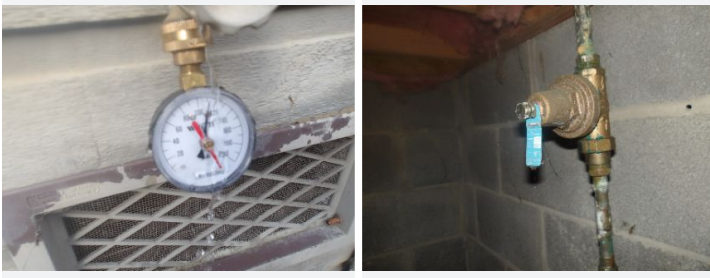
Water pressure tested high at 110psi.

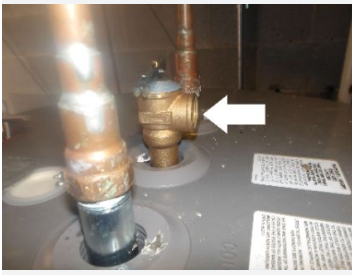
Drain tube needs to be installed on the TPRV that extends to within 6' of the floor.

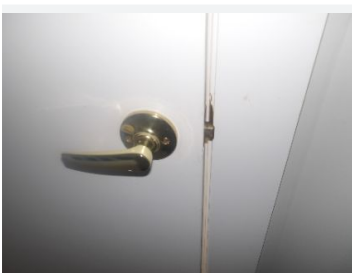
No privacy lock at entry door.

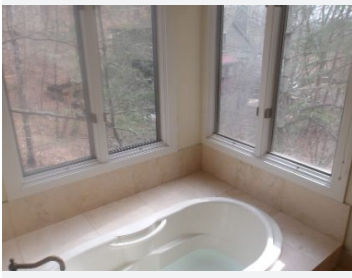
Window around tub could not be opened do to missing crank handles.

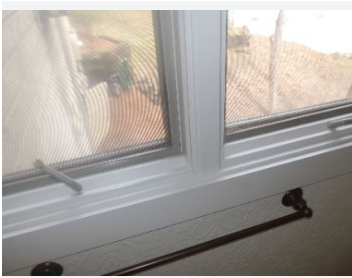
Water closet windows did not open.

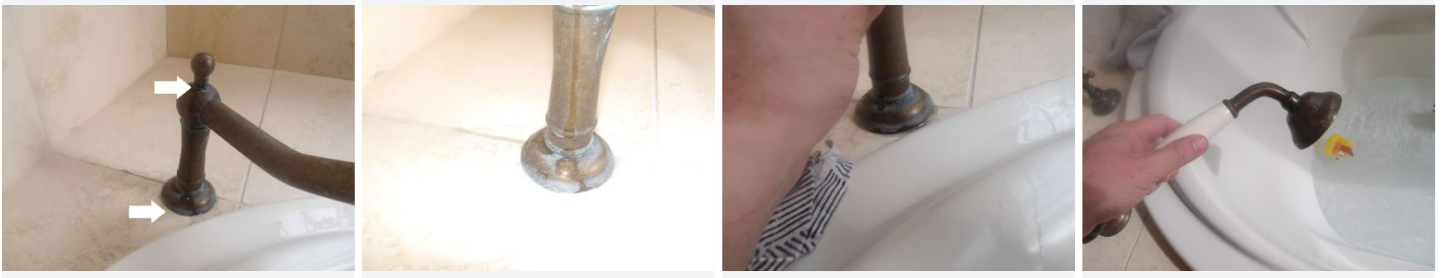
Tub faucet is loose at base and leaks when valve is open.

Hand spray wand did not engage.

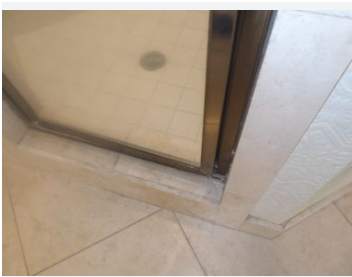
Shower door sticks.

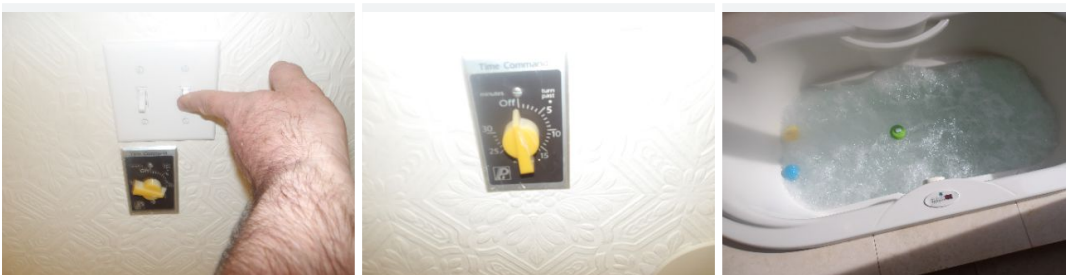
Timer did not turn off spa function.

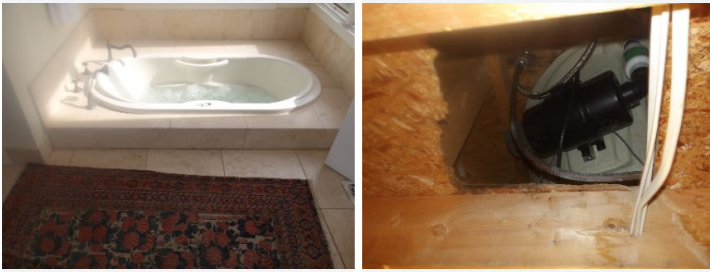
Spa motor is only accessible from mechanical closet in basement below.

No GFCI protection located for spa motor circuit.

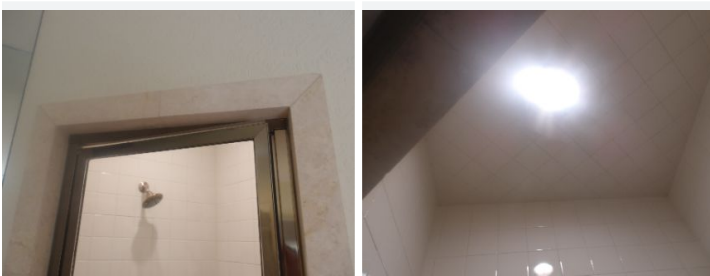
No venting noted for the shower stall.

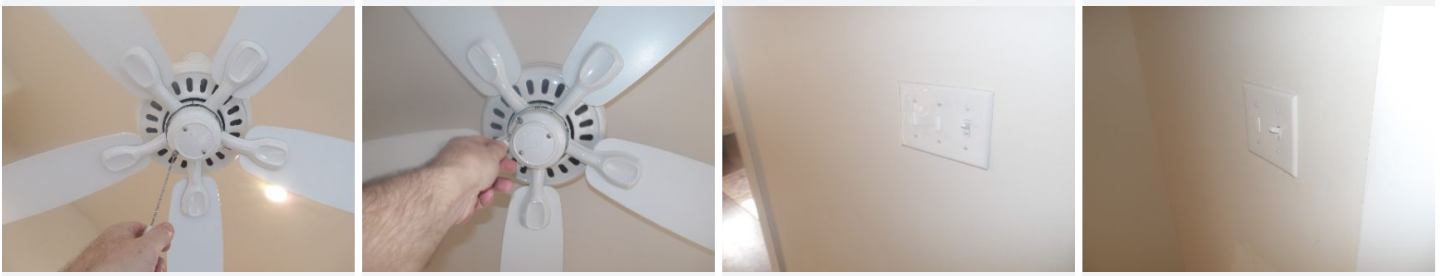
Both ceiling fans did not engage.

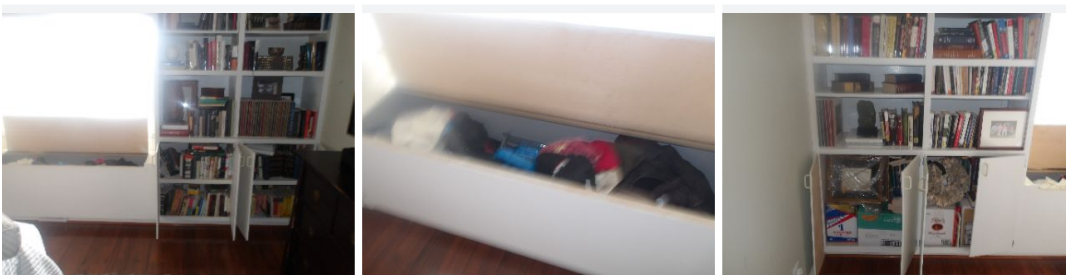
No outlets visible to service the rear wall.

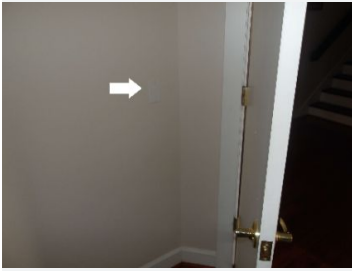
Possible switch location is behind the door.

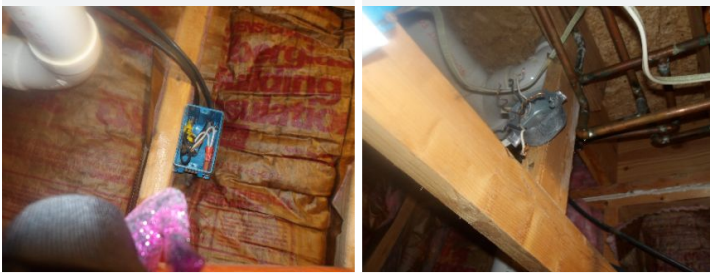
Open junction boxes in mechanical closet.  
No current at ceiling outlet in mechanical closet.

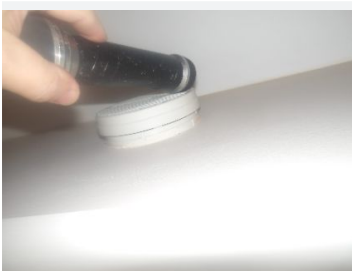
Smoke detector did not respond.

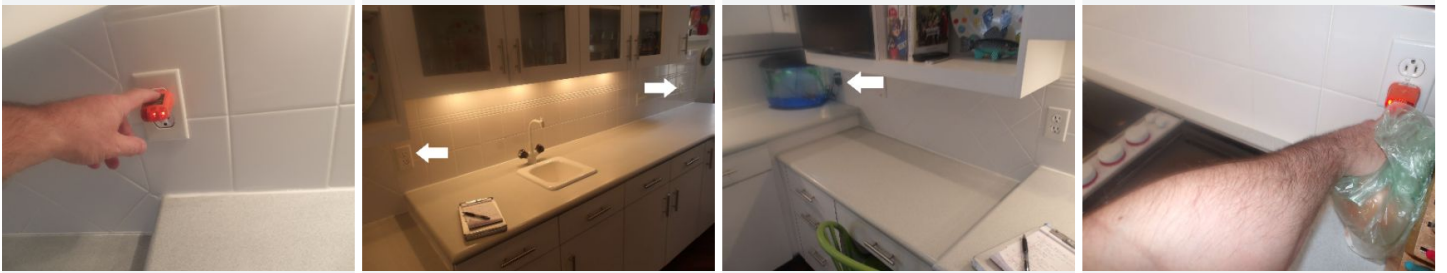
No GFCI protection noted at rear wall counter outlets or outlet at cook top counter.

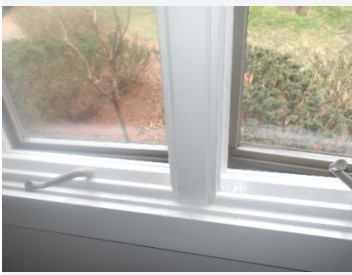
Windows did not operate/open properly.
